# Manhole Inspection Summary

Manhole # S33Q\_\_019MH

Insp Date: **8/21/08 2:11 PM**

**Location** Address: **250 s howard st**

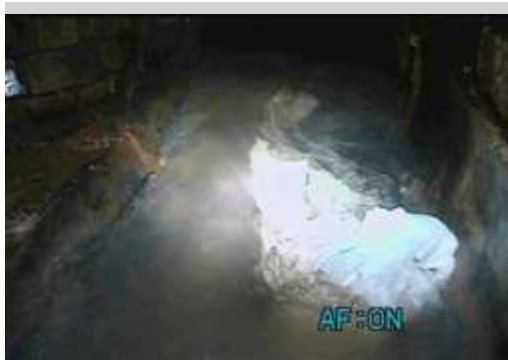
Miscellaneous

channel debris

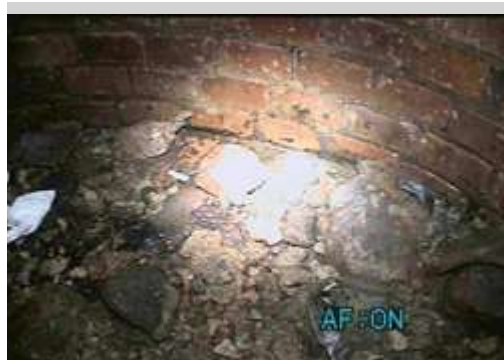
Miscellaneous

bench debris

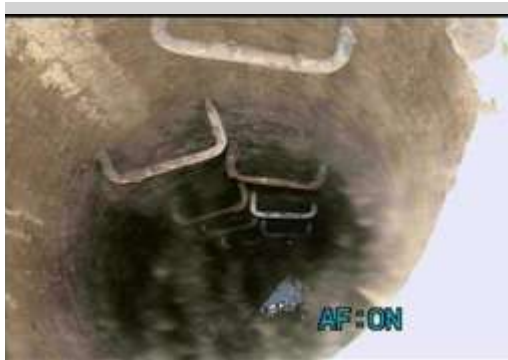
Defect 1

Count: **10** Missing: **0** ☒ **Corroded**

steps

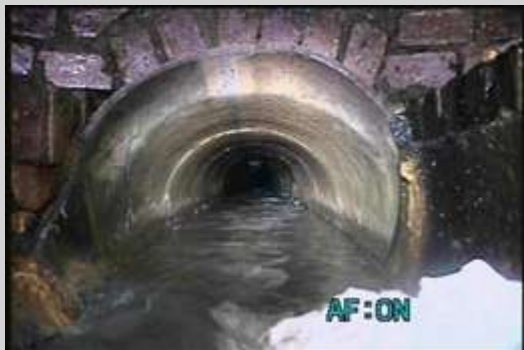
12 O'Clock Outflow

15 in. Circular Gravity Sewer  
Pipe Out @ 12 O'Clock

Pipe Material: **Clay** ☐ Pipe Lined

Invert Depth: **16.00** (ft.) Flow Characteristics: **Fast**

Deposits: ☒ None ☐ Mud ☐ Sludge ☐ Debris ☐ Grease

Infiltration: **None** Pipe Seal Cond: **Unknown**

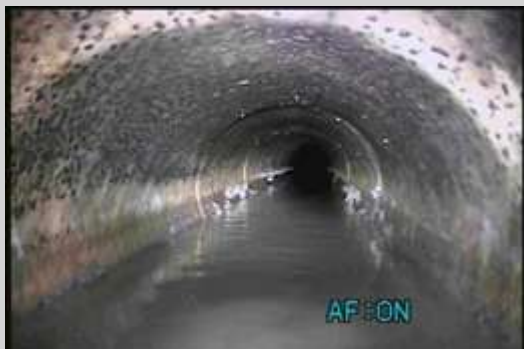
6 O'Clock Inflow

15 in. Circular Gravity Sewer  
Pipe In @ 6 O'Clock

Pipe Material: **Clay** ☐ Pipe Lined

Invert Depth: **15.66** (ft.) Flow Characteristics: **Fast**

Deposits: ☒ None ☐ Mud ☐ Sludge ☐ Debris ☐ Grease

Infiltration: **None** Pipe Seal Cond: **Unknown**

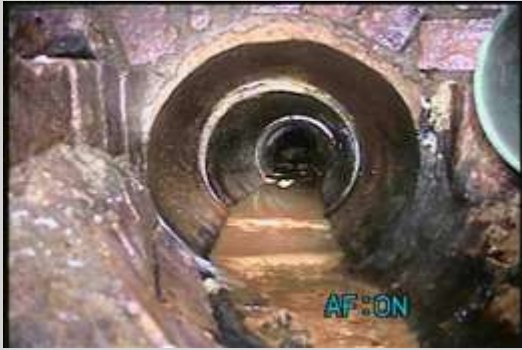
9 O'Clock Inflow

8 in. Circular Gravity Sewer

Pipe In @ 9 O'Clock

Pipe Material: **Clay** ☐ Pipe Lined

Invert Depth: **15.63** (ft.) Flow Characteristics: **Slow**

Deposits: ☒ None ☐ Mud ☐ Sludge ☐ Debris ☐ Grease

Infiltration: **None**

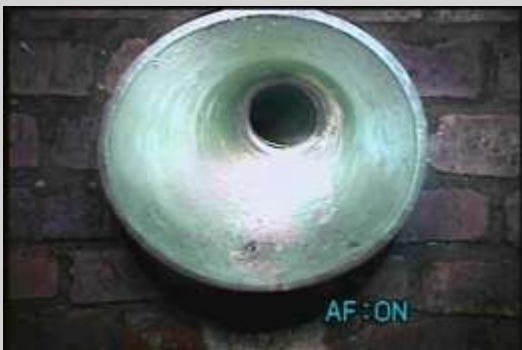
10 O'Clock Inflow

8 in. Circular Gravity Sewer

Pipe In @ 10 O'Clock

Pipe Material: **PVC** ☐ Pipe Lined

Invert Depth: **10.50** (ft.) Flow Characteristics: **None**

Deposits: ☒ None ☐ Mud ☐ Sludge ☐ Debris ☐ Grease

Infiltration: **None**

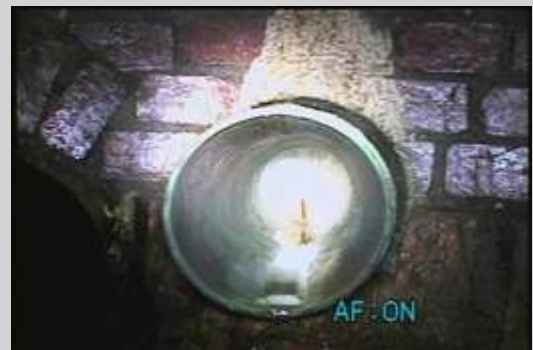
Drop In @ 10 O'Clock

Drop: **Outside Direct**

Inv Depth: **14.66** (ft.)

Drop Condition: **Open**
